HALL DAM

ATCHISON COUNTY, MISSOURI

MO. 11038

**PHASE 1 INSPECTION REPORT
NATIONAL DAM SAFETY PROGRAM**

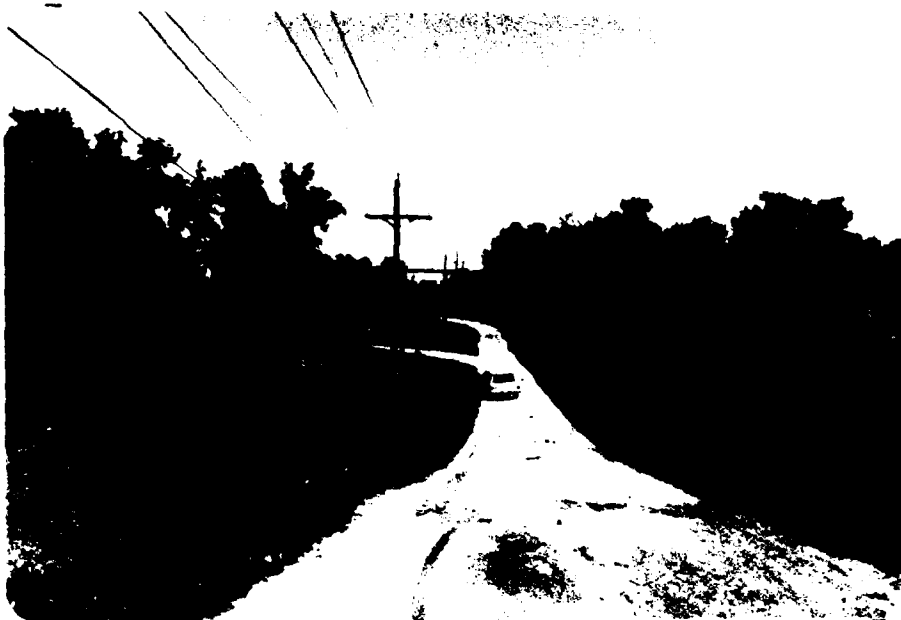
PHOTO NO. 16 - VIEW LOOKING NORTH SHOWING DRAINAGEWAY
DOWNSTREAM FROM DAM AT FIRST ROAD CROSSING.
